Manhole Inspection Summary

Manhole # S13AA2012MH

Insp Date: **7/25/06 1:08 PM**

Location Address: **5609 CROSS COUNTRY BLVD**

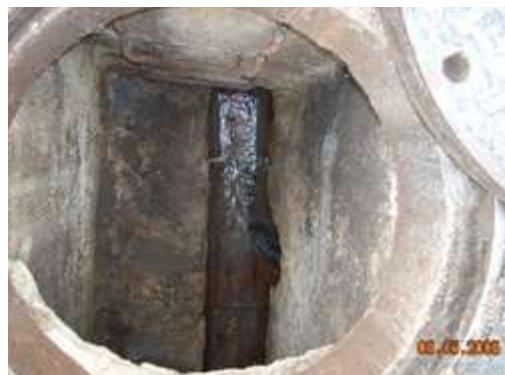
Top View

Corroded and missing steps. Corbel and Barrel infiltration. Bench debris.

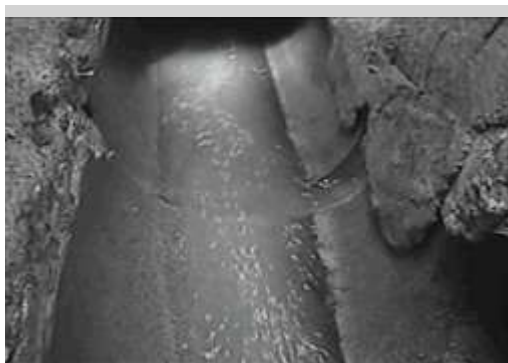
Defect

Channel gap.

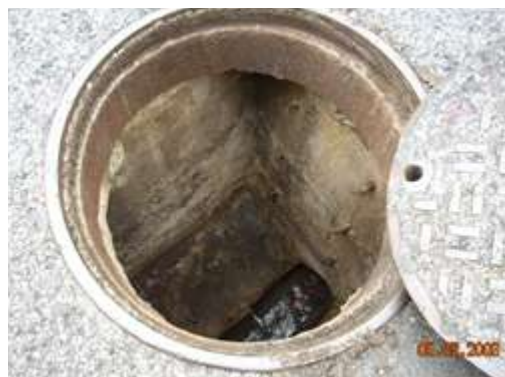
Defect

Frame leaks. Corbel deterioration and infiltration. Barrel infiltration.

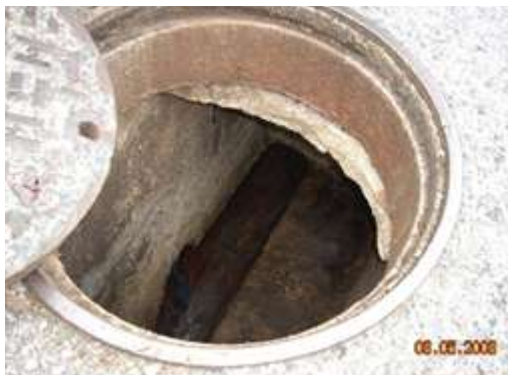
Defect

Frame leaks. Corbel deterioration and infiltration. Barrel infiltration - other side.

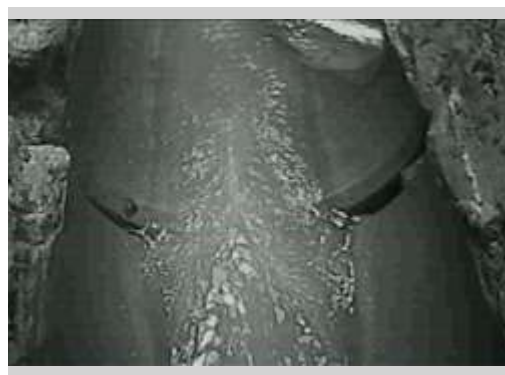
Defect

Second Channel gap.

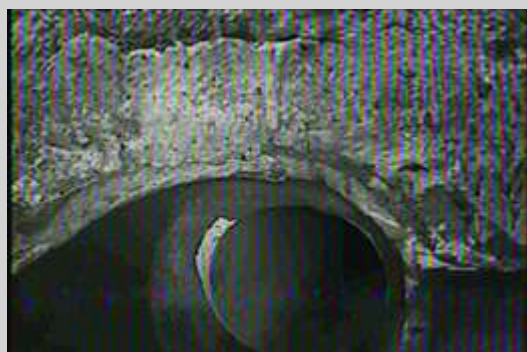
Pipe In @ 3 O'Clock

Infiltration: **Evidence** Pipe Seal Cond: **Broken**

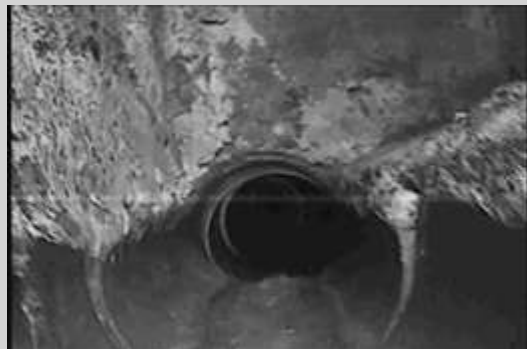
Pipe In @ 6 O'Clock

Infiltration: **Weeper**
